CENTRALINA MOBILITY MANAGEMENT

WALK AUDIT REPORT

AUGUST 2021

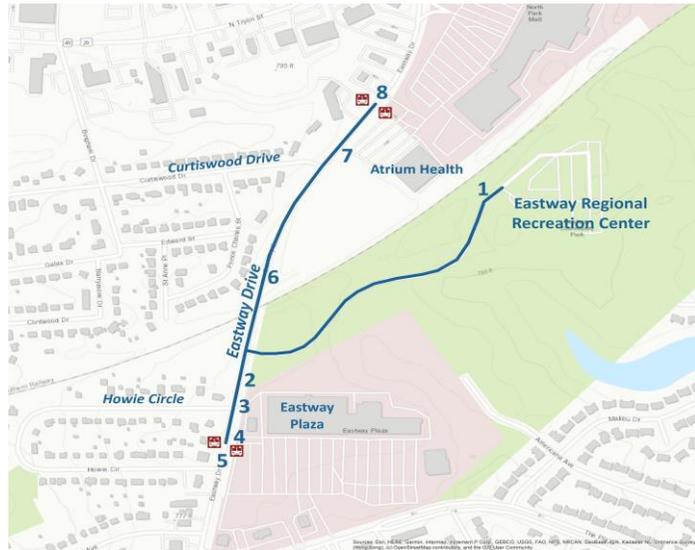
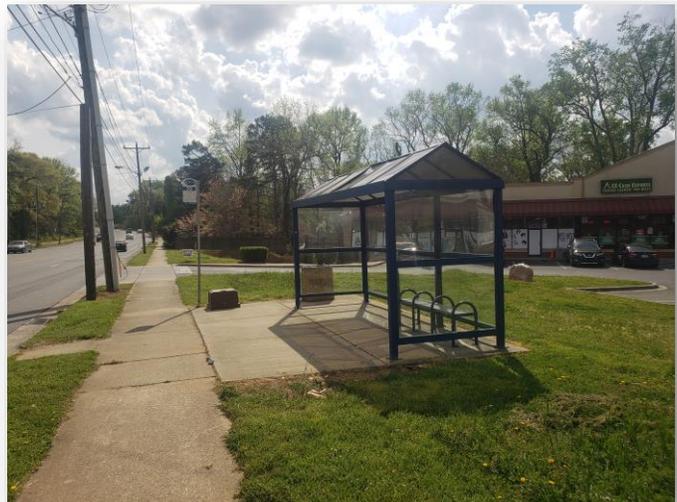
On March 8, 2021, Matthew Gallman (Centralina) conducted a walkability audit to and from transit stops on Eastway Drive near Eastway Regional Recreation Center. This route was 0.9 miles or 15 minutes long one-way. The route was walked to examine the 2 transit stops.

FINDINGS		RECOMMENDATIONS
SIDEWALKS		
Width, Design, Gaps	Sidewalks along Eastway Park Drive are wide with sufficient buffering and street trees. Transitioning to Eastway Drive, sidewalks are narrow, in most cases only four feet, with minimal buffering to shield pedestrians from the street.	<ul style="list-style-type: none"> • Widen sidewalks along Eastway Drive • Plant street trees or shrubbery along Eastway Drive to promote feeling of safety and increase curb appeal • Review strategies from the Charlotte Eastway Drive Streetscape and Pedestrian Improvement Study
Obstructions, Debris, Grass, Cracking	Accumulation of grass and dirt in multiple areas of sidewalk. These areas are difficult for individuals using wheelchairs or other mobility devices to navigate. There is mild cracking in multiple locations and could present a trip hazard.	<ul style="list-style-type: none"> • Trim grass and shrubbery • Remove existing dirt along Eastway Drive • Review or develop tracking and implementation strategy(ies) for sidewalk maintenance (cracking) on Eastway Drive

BUS STOPS		
Shelter, Amenities, Design	Bus stops at Eastway plaza are missing shelter. Sidewalk buffering along the southbound Eastway plaza bus stop is barrier for individuals entering or exiting bus. Trash receptacle overflowing at southbound bus stop near Atrium Health.	<ul style="list-style-type: none"> • Provide shelter with lighting and seating at all locations • Relocate obstructing trash receptacle at Eastway Plaza bus stop • Provide benches with wheelchair cutaway at all locations • Provide surface to lean against if seating cannot be provided • Schedule frequent cleaning of trash receptacles at all locations • Provide direct passenger access to bus where grass buffer(s) exist near Eastway Plaza
CROSSWALKS		
ADA, Safety, Refuge	Crosswalks near Eastway Plaza are not ADA compliant. Center refuge adjacent to Eastway Park Drive is in great condition and has ADA compliant curb ramps. Additional traffic calming measures should be considered at refuge. Crosswalk near Atrium Health lacks ADA compliant ramps, and their placement could be a challenge to individuals with limited mobility.	<ul style="list-style-type: none"> • Install ADA compliant curb ramps at Eastway Plaza • Consider additional traffic calming measures at refuge near Eastway Park Drive. Thermoplastic Crosswalk and/or controlled crossing could be added to facility • Install ADA compliant curb ramps at crosswalk near Atrium Health. Truncated domes needed

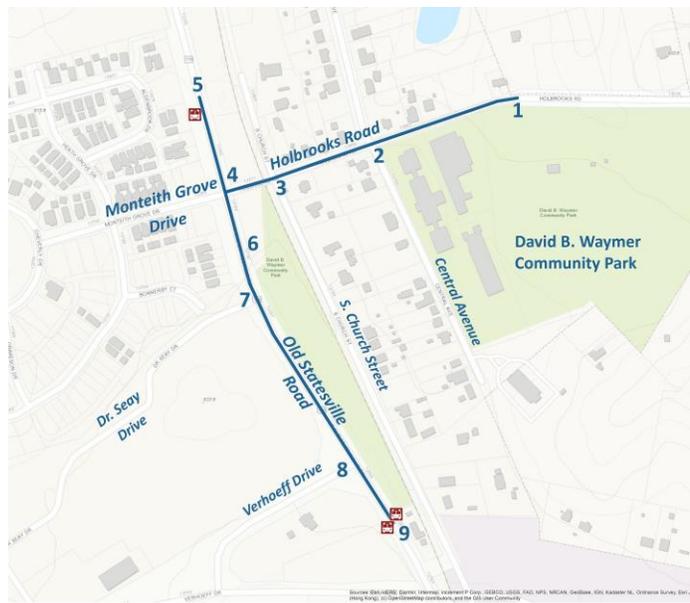
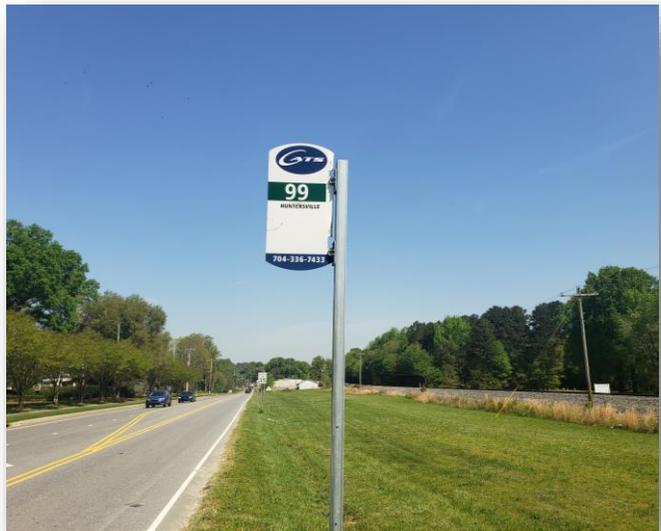
On March 8, 2021, Matthew Gallman (Centralina) conducted a walkability audit to and from transit stops located on Old Statesville Road near David B. Waymer Community Park. This route was 0.5 miles or 10 minutes long one-way. The route was walked to examine the 2 transit stops..

FINDINGS		RECOMMENDATIONS
SIDEWALKS		
Width, Design, Gaps	The sidewalk along Holbrooks Road is illuminated by street lighting on opposite side of road. There is a significant gap in pedestrian infrastructure beginning at the intersection of Holbrooks Road and Central Avenue. Holbrooks Road provides a sense of place for pedestrians but is lacking quality infrastructure.	<ul style="list-style-type: none"> Widen the sidewalks along Holbrooks Road Consult, document and champion the completion of sidewalk facilities along Holbrooks Road
Obstructions, Debris, Grass, Cracking	Walking along Holbrooks Road the sidewalk is narrow with upheaved pavement which creates a trip hazard.	<ul style="list-style-type: none"> Repair upheaved sidewalk plates along Holbrooks Road near David B. Waymer Park
BUS STOPS		
Shelter, Amenities, Design	The sidewalk gap along Holbrooks Road is an impediment to accessible transit. All bus stops along Old Statesville Road are missing shelter. Both stops near 12810 Old Statesville Road lack adequate lighting. Both stops near 12810 Old Statesville Road placed in grass with broken/no pedestrian seating. Trash receptacles near 12810 Old Statesville Road encroach on pedestrian waiting space.	<ul style="list-style-type: none"> Provide shelter with lighting and seating at locations along Statesville Road Provide benches with wheelchair cutaway at all stations along Statesville Road Repair/provide pedestrian seating area at both stops near 12810 Old Statesville Road. Provide paved waiting area for pedestrians using wheelchair at bus stops near 12810 Old Statesville Road.

CROSSWALKS		
ADA, Safety, Refuge	Crosswalks along Holbrooks Road are not ADA compliant. Multiple points lack ADA compliant curb cuts due to gaps in sidewalk infrastructure. Crosswalk at the intersection of Old Statesville Road and Holbrooks Road is missing curb cuts needed to cross Old Statesville Road. The crossing at the intersection of old Statesville Road and Dr. Seay Drive lacks ADA compliant curb cuts and does not provide for good visibility of pedestrians. The crossing at the intersection of Old Statesville Road and Verhoeff Drive is a controlled pedestrian crossing and brings awareness to the vehicular traffic that is approaching the intersection.	<ul style="list-style-type: none"> Install ADA compliant curb cuts along with new sidewalks to fill in gaps along Holbrooks Road Install ADA compliant curb cuts along with new sidewalks to fill in gaps along Holbrooks Road Install ADA Compliant curb ramps at the intersection of Old Statesville Road and Dr. Seay Drive. Make efforts to relocate utility boxes at the intersection of Old Statesville Road and Dr. Seay Drive to increase driver visibility. Determine best practices for sidewalk/railway intersections

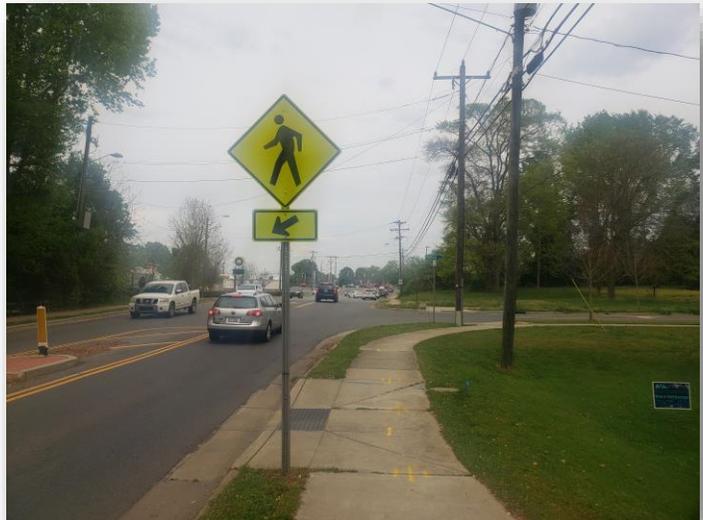
On March 14, 2021 Matthew Gallman (Centralina) conducted a walkability audit to and from transit stops located near Sardis Trace Apartments. This route was 0.4 miles or 8 minutes long one-way. This walking route examined 1 bus stop located on Monroe Road.

FINDINGS		RECOMMENDATIONS
SIDEWALKS		
Width, Design, Gaps	The sidewalks along Nolley Court are in great condition (new), and sufficiently wide with no needed improvements. Buffering and lighting is provided along Nolley Court. Walking towards the bus station, sidewalks gradually narrow to four feet. Nearing Sardis Village exists a major gap in sidewalk infrastructure. Compounding the negative effect(s) of missing sidewalk is running slope which will be challenging for individuals with limited mobility to traverse.	<ul style="list-style-type: none"> • Consult, document, and champion the completion of sidewalk facilities along Nolley Court • Consider the provision of handrails that will compliment future sidewalks built on land with aggressive running slope.
Obstructions, Debris, Grass, Cracking	No cracking or obstructions were observed during walk audit.	
BUS STOPS		
Shelter, Amenities, Design	Stops along Monroe Road missing shelter. The sidewalk gap along Nolley Court is an impedes on accessible transit. Stops are dependent on street lighting which may not be sufficient for pedestrian security. The southbound stop on Monroe Road does not have seating area. Additionally, no trash receptacle is available.	<ul style="list-style-type: none"> • Provide bus shelter with lighting at both stops on Monroe Road near Nolley Court • Provide bench at southbound bus stop on Monroe Road • Provide at southbound bus stop on Monroe Road • Provide surface for pedestrians to lean against at bus stops

CROSSWALKS		
ADA, Safety, Refuge	Existing crosswalks along Nolley Court are in great condition and ADA compliant. Nolley Court encourages low traffic speeds and pedestrian awareness. Nolley Court crossings feels safe for pedestrians. The northern curb ramp at the intersection of Nolley Court and Monroe Road is missing ADA compliant truncated domes and is improperly positioned.	<ul style="list-style-type: none"> • Install ADA compliant curb ramp at intersection of Nolley Court and Monroe Road.

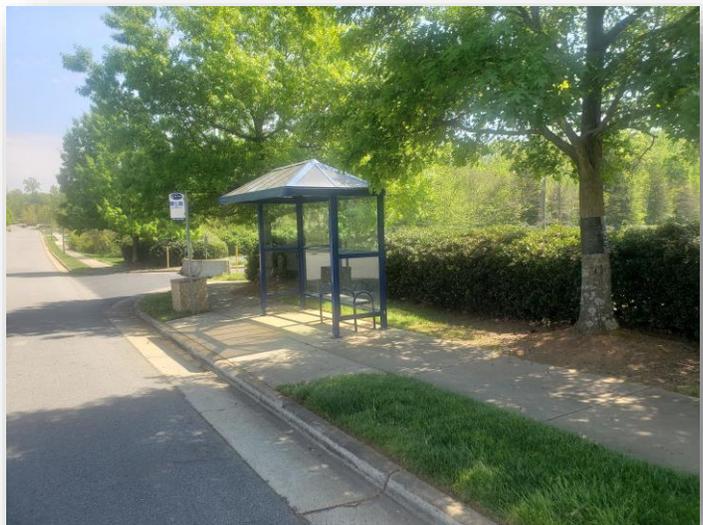
On March 14, 2021, Matthew Gallman (Centralina) conducted a walkability audit to and from transit stops located near the North Charlotte VA Clinic. This route was 0.3 miles or 6 minutes long one-way. The route was walked to examine the 2 transit stops and surrounding pedestrian infrastructure.

FINDINGS		RECOMMENDATIONS
SIDEWALKS		
Width, Design, Gaps	The sidewalks are in great condition but only four feet wide on East University Drive. Street lighting is consistent along the entire route. Individuals of varying mobility should be able to traverse this location, no major barriers exist. However, adjacent land uses are not pedestrian friendly due do empty buildings and abandoned lots.	<ul style="list-style-type: none"> Widen sidewalks to accommodate additional foot traffic along East University Drive Coordinate with owners of abandon/vacant lots to utilize for pedestrian friendly outdoor activities and amenities. Make effort to provide street trees along East University Drive
Obstructions, Debris, Grass, Cracking	Mild cracking and upheaved sidewalk plates exists along University East and Back Creek Drive.	<ul style="list-style-type: none"> Review or develop tracking and implementation strategies for sidewalk maintenance and apply to intersection of University East Drive and Back Creek Drive

BUS STOPS		
Shelter, Amenities, Design	<p>Bus stop along Back Creek Drive provides bench and shelter but is missing lighting. The bus stop is well positioned, allowing easy curb access to buses. Trash receptacles are appropriately placed beside pedestrian walkway. The bus stop location feels safe and inviting but is not located conveniently close to the Charlotte VA clinic.</p> <p>The bus stop near the intersection of University East Drive and W.T. Harris Boulevard is missing shelter, seating, and lighting on both sides of street. However, the bus stop is in an convenient and inviting location.</p>	<ul style="list-style-type: none"> Provide surface to lean against if seating cannot be provided at bus stop near W.T. Harris Boulevard Relocate stop nearest North Charlotte VA clinic for better accessibility for persons with limited mobility. Provide trash receptacles at all bus stops near North Charlotte VA.

CROSSWALKS		
ADA, Safety, Refuge	Crosswalks along University East Drive are in fair condition but not all curb ramps are ADA compliant. Multiple curb ramps along University East Drive are angled in such a way individual with wheelchairs may have trouble accessing. Multiple ramps are missing ADA compliant truncated domes. Traffic speeds our relatively high and driver negligence for pedestrians seems to be common.	<ul style="list-style-type: none"> Install ADA compliant curb ramp at intersection of University East Drive and Back Creek Drive. Consider traffic calming measures along University East Drive such as “speed humps” Reconstruct/reposition curb cuts at intersection of University East Drive and Back Creek Drive.

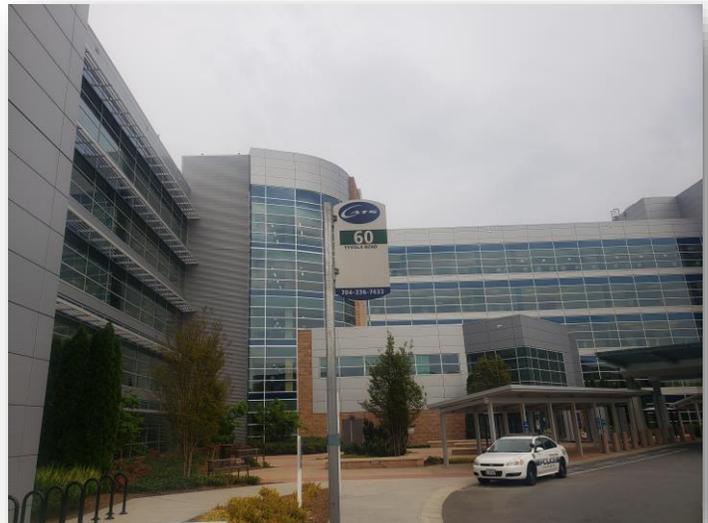
On March 14, 2021, Matthew Gallman (Centralina) conducted a walkability audit to and from transit stops located near the South Charlotte VA Clinic. This route was 0.3 miles or 7 minutes long one-way. The route was walked to examine the 2 transit stops and surrounding pedestrian infrastructure.

FINDINGS		RECOMMENDATIONS
SIDEWALKS		
Width, Design, Gaps	Sidewalks located within the South Charlotte VA Clinic parking area are in great condition and are six feet wide. This location supports individuals with varying levels of mobility. When exiting the facility, streetlights are missing along Cascade Pointe Boulevard and construction projects/open fields detract from sense of place. Additionally, the sidewalks along Cascade Point Boulevard have a running slope that may be difficult to traverse for individuals with limited mobility.	<ul style="list-style-type: none"> Consider pedestrian railing along Cascade Pointe Boulevard to offset negative impact of running slope. Consider pedestrian railing along West Tyvola Road sidewalk near bus to offset negative impacts of running slope.
Obstructions, Debris, Grass, Cracking	No cracking or obstructions were observed during walk audit	
BUS STOPS		
Shelter, Amenities, Design	Bus stop at clinic entrance provides immediate access for transit riders. Both stops are missing shelter and benches. However, both stops are placed in an inviting location. An emergency call box to the Charlotte-Mecklenburg police department is located near VA Clinic stop for added sense of security. The stop located on West Tyvola Road is placed on naturally sloped land and may prove difficult to access for some.	<ul style="list-style-type: none"> Provide shelter with lighting and seating at both VA Clinic bus stops Provide surface for pedestrians to lean against at bus stops. Wayfinding signage with large text should be placed in vicinity of North Charlotte VA Clinic to help transit riders locate West Tyvola bus stop

CROSSWALKS		
ADA, Safety, Refuge	South Charlotte VA is walkable but curb cuts are missing at vital locations which prohibit a complete micro mobility network. There are two missing crosswalks located at a primary internal crossing before reaching Cascade Point Boulevard. Vehicles do not acknowledge pedestrians due to absence of curb cuts at internal crossings. The crossing parallel to Cascade Pointe Boulevard before reaching West Tyvola feels safe, while crossing perpendicular to Cascade Point Boulevard feels too far for universal transit rider accessibility.	<ul style="list-style-type: none"> Install ADA compliant curb ramp at intersection of University East Drive and Back Creek Drive. Consider traffic calming measures along University East Drive such as "speed humps" <i>Reconstruct/position curb cuts at intersection of University East Drive and Back Creek Drive.</i>

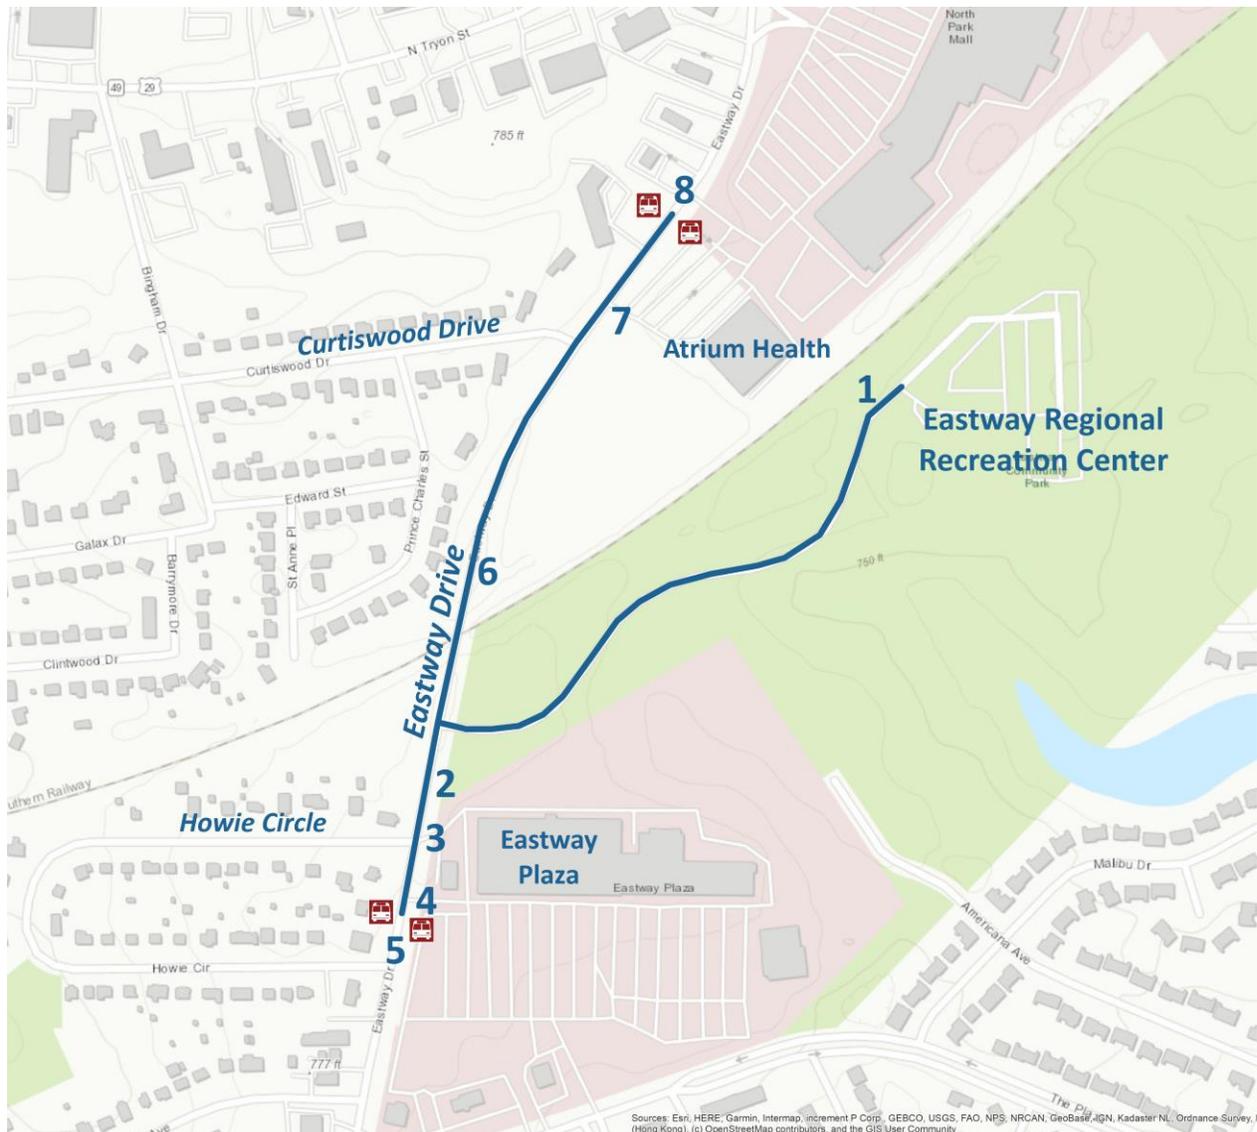
Route: Eastway Regional Recreation Center

Location 1: Walking along road away from future Eastway Regional Recreation Center

- What could make this sidewalk safer for pedestrians, especially those with disabilities? The sidewalk is in excellent condition. ADA compliant street furniture should be provided.

Notes: Refuge crossing is new, and in very good condition/ADA Compliant

Notes: Crossing adjacent to Eastway Drive has mild cracking but crossing distance is comfortable. Crossing perpendicular to Eastway Drive is arduous with no signal/assistance. Continuous traffic flow may prove difficult for persons with disabilities.

Notes: Crosswalk paint fading, but in good condition. Although bus shelter on single side of street, pedestrians should feel comfortable switching sides during inclement weather.

Location in overall decent condition with room for improvement. Pedestrians may not feel like a priority while walking along Eastway Drive.

Ensure items such as trash receptacles properly placed and secured to provide for most equitable conditions for pedestrians.

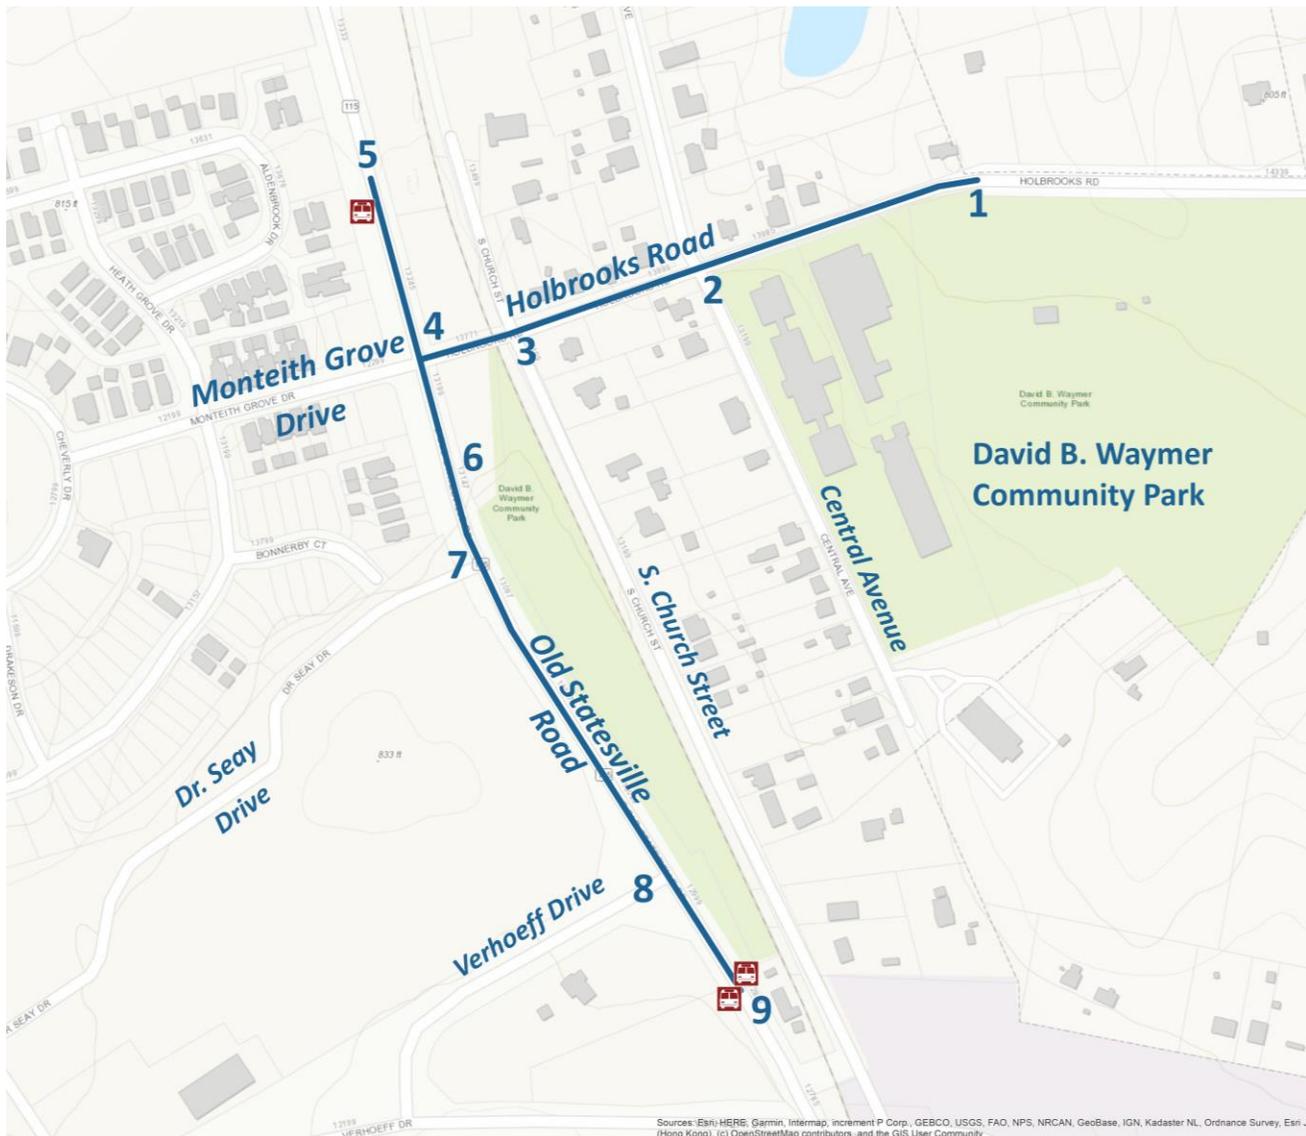
Route: David. B Waymer Community Park

Location 1: Walking along Holbrooks Road away from David. B. Waymer Community Park
